**Flood Control Project Maintenance**  
**2008 Structure Summary Report**  
**Overall Unit and Item Ratings**

**Sacramento County**

**American River Pumping Plant No. 1 Howe Avenue Storm Drain D - 05**

**American River Pumping Plant No. 2 Willhaggin Storm Drain D - 43**

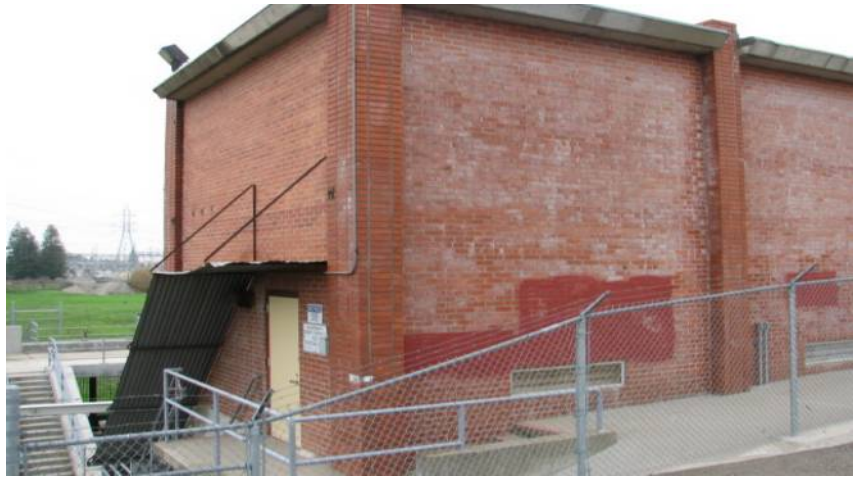
Report Line	3
Location	
Category	Pump Stations
Item	Plant Building
Plant building is brick. No deterioration or cracking is visible.

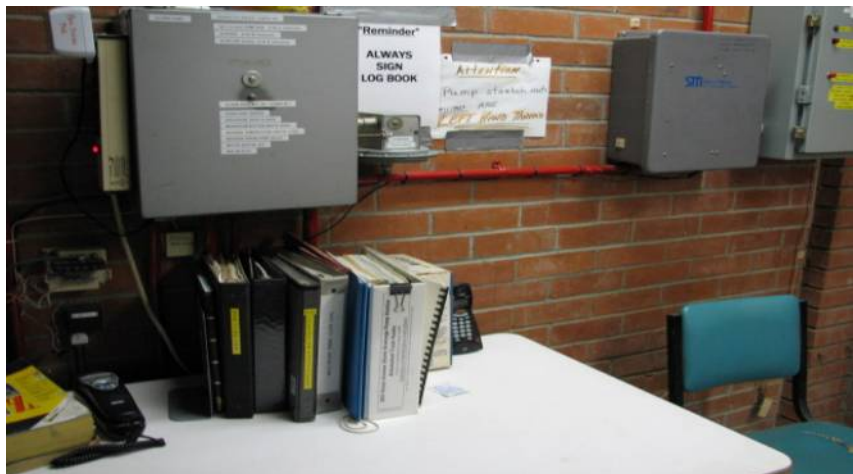
Report Line	4
Location	
Category	Pump Stations
Item	Communications
Communications area within the station.

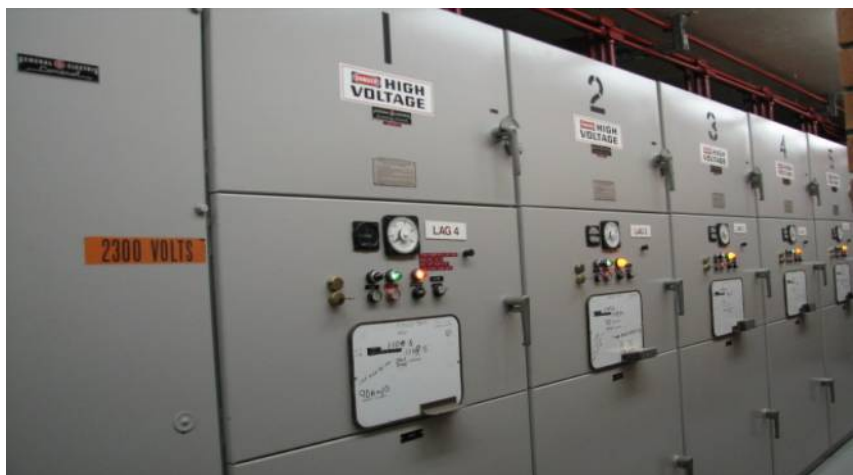
Report Line	10
Location	
Category	Pump Stations
Item	Pump Control Systems
Pump control/power.

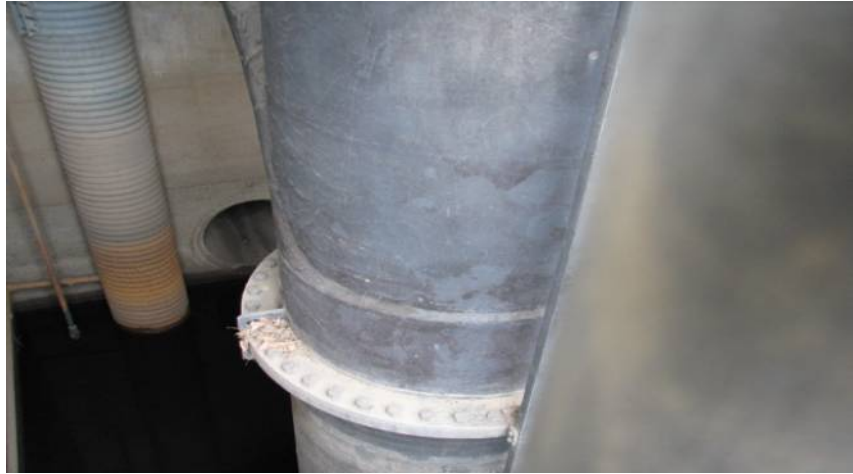
Report Line	11
Location	
Category	Pump Stations
Item	Sumps/Wet Well

View down wet-well. Clear of debris.

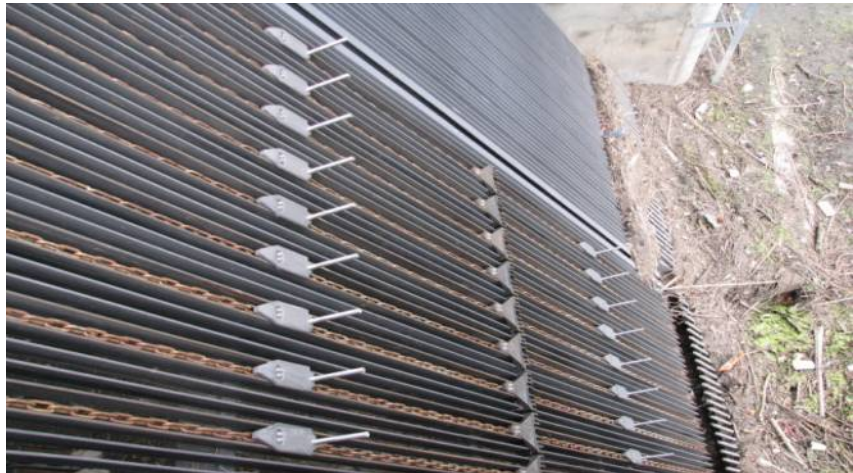
Report Line	12
Location	
Category	Pump Stations
Item	Trash Racks

View of trash racks. Chain driven trash rakes can also be seen.

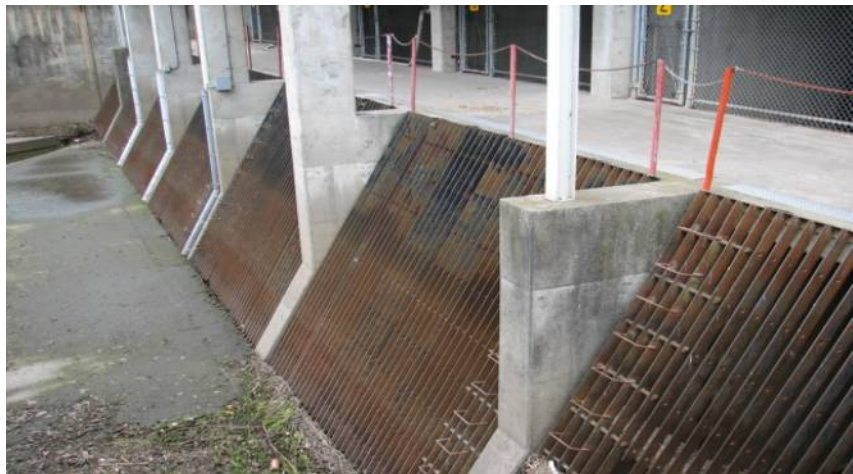
Report Line	12
Location	
Category	Pump Stations
Item	Trash Racks

View of original trash racks which are situated behind the chain driven trash rack installation. These now function as a secondary system.

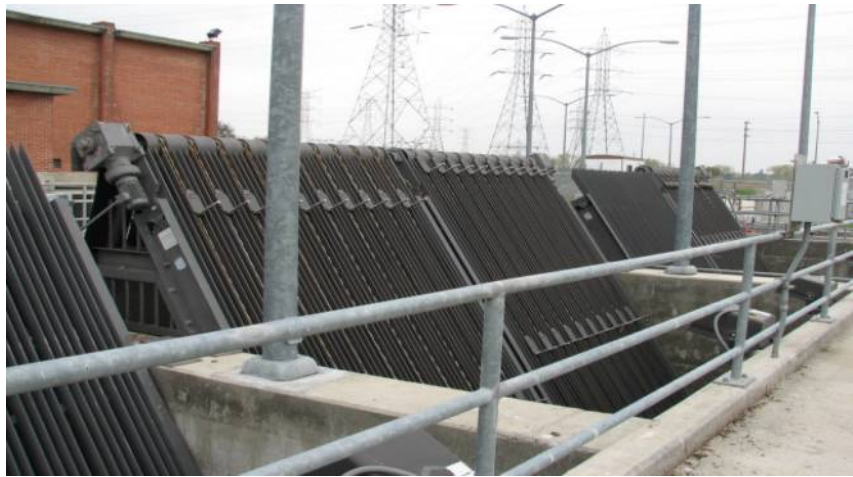
Report Line	13
Location	
Category	Pump Stations
Item	Trash Rakes

Top of trash racks where chain driven rakes are controlled.

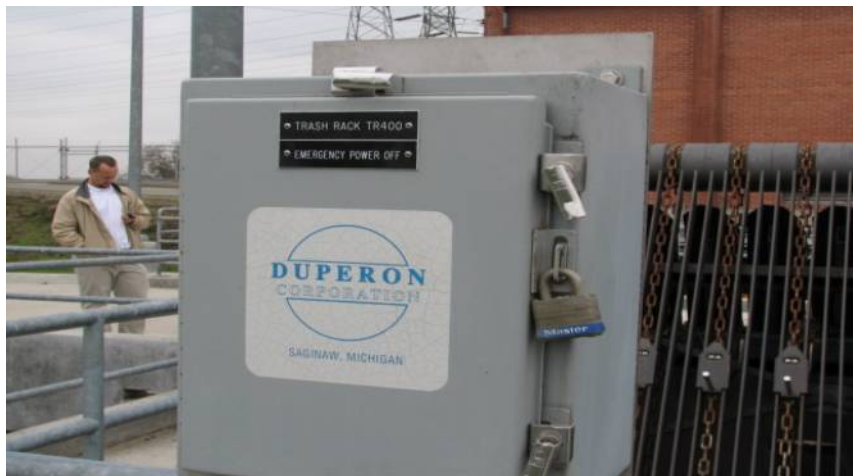
Report Line	13
Location	
Category	Pump Stations
Item	Trash Rakes

Power for the chain drive.

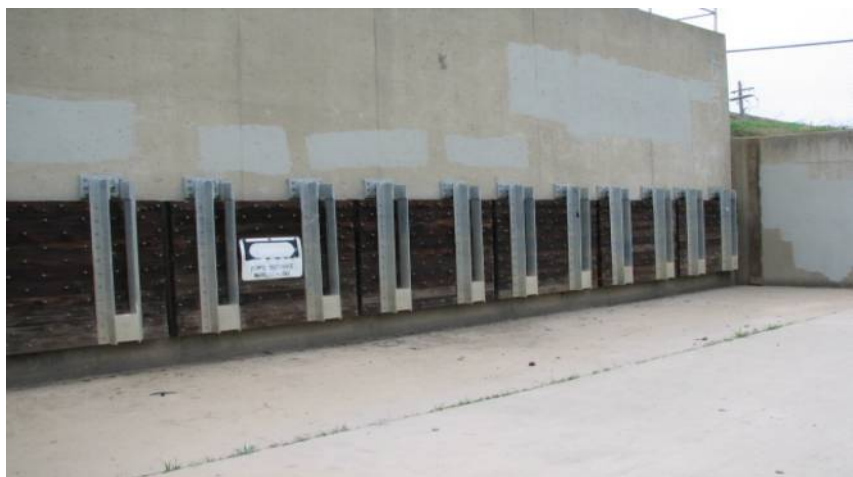
Report Line	18
Location	
Category	Pump Stations
Item	Flap Gates

Rpt Line	Category	Item	Location *	Rating **	Comment	GPS	Photo	Issue
18	Pump Stations	Flap Gates		A	Item inspected visually only. Item was not operated during the inspection.			Y 18
19	Pump Stations	Closure Structures		N				19
20	Pump Stations	Security Fencing		A				Y 20
21	Pump Stations	Intake and Discharge Pipes		N	Pipes could not be seen.			21
22	Pump Stations	Pressurized Pipe		N	Pipes could not be seen.			22

Flap gates.

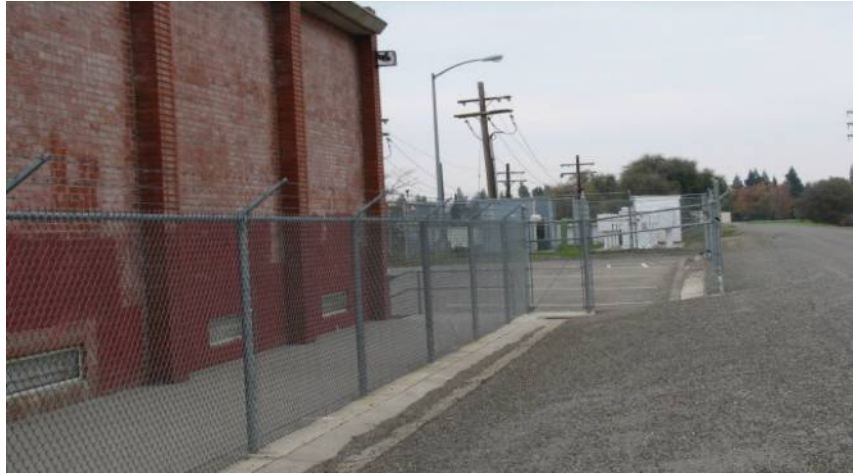
Report Line	20
Location	
Category	Pump Stations
Item	Security Fencing

Security fencing completely encloses the station and is topped with barbed wire.

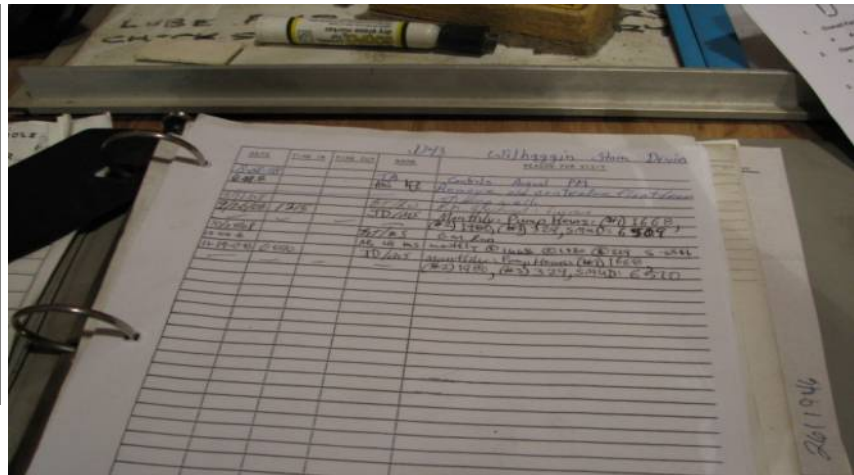
Report Line	1
Location	
Category	Pump Stations
Item	Operating Log

Maintenance and operations log indicates regular care is taken.

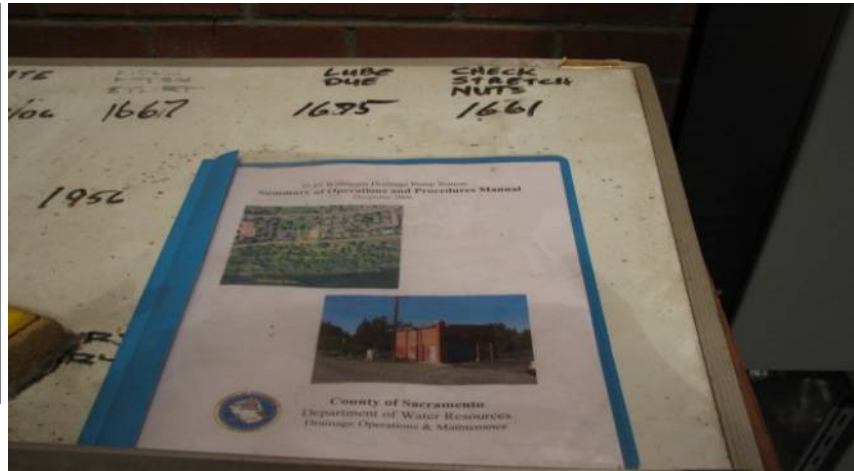
Report Line	2
Location	
Category	Pump Stations
Item	Operation & Maintenance Manual

County O&M manual present.

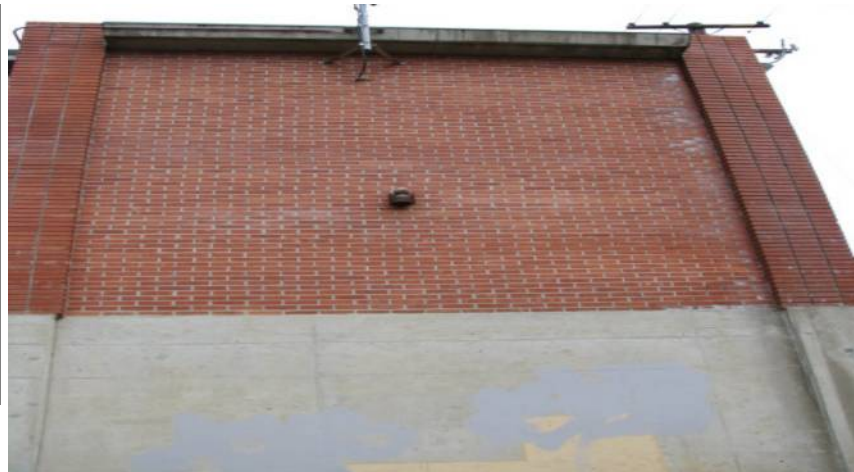
Report Line	3
Location	
Category	Pump Stations
Item	Plant Building

Rpt Line	Category	Item	Location *	Rating **	Comment	GPS	Photo	Issue
1	Pump Stations	Operating Log		A			° Y	1
2	Pump Stations	Operation & Maintenance Manual		A			° Y	2
3	Pump Stations	Plant Building		A	Note that there is a 3-4inch deflection of the retaining wall. This deflection has been there for about a decade.		° Y	3
4	Pump Stations	Communications		A			°	4
5	Pump Stations	Safety		A			°	5
6	Pump Stations	Cranes		N			°	6
7	Pump Stations	Pumps		A	Item inspected visually only. Item was not operated during the inspection.		°	7
8	Pump Stations	Power		A			° Y	8
9	Pump Stations	Motors, Engines, Fans & Gear Reducers		A	Item inspected visually only. Item was not operated during the inspection.		°	9
10	Pump Stations	Pump Control Systems		A			° Y	10
11	Pump Stations	Sumps/Wet Well		A			° Y	11
12	Pump Stations	Trash Racks		A	Trash racks are manually cleared of debris regularly.		° Y	12
13	Pump Stations	Trash Rakes		N			°	13

Pump station exterior has no visible cracking, appears structurally sound.

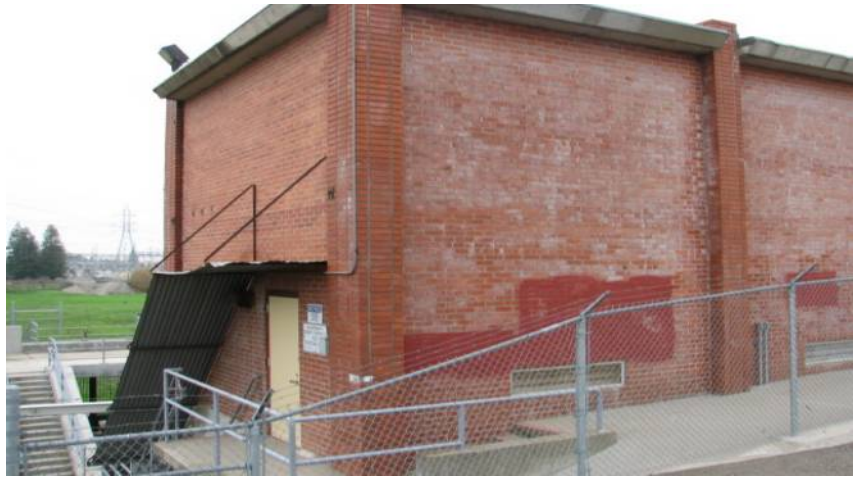
Report Line	3
Location	
Category	Pump Stations
Item	Plant Building

Another view.

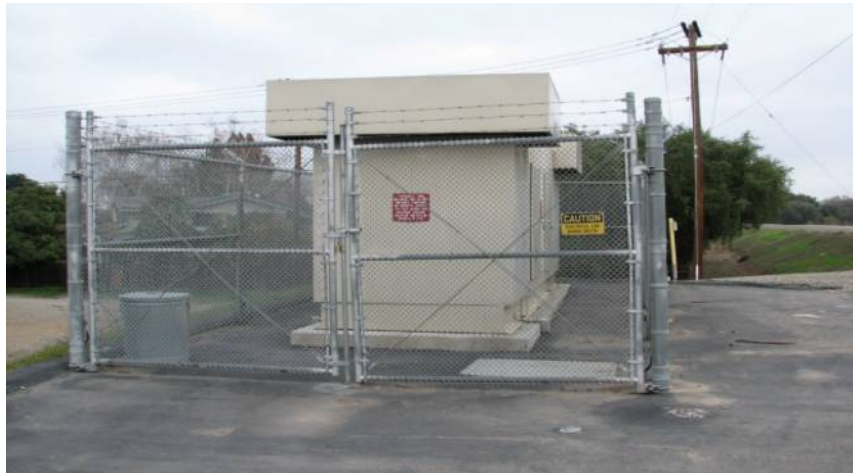
Report Line	8
Location	
Category	Pump Stations
Item	Power

Generators are housed within this fencing approximately 20' from the pump station.

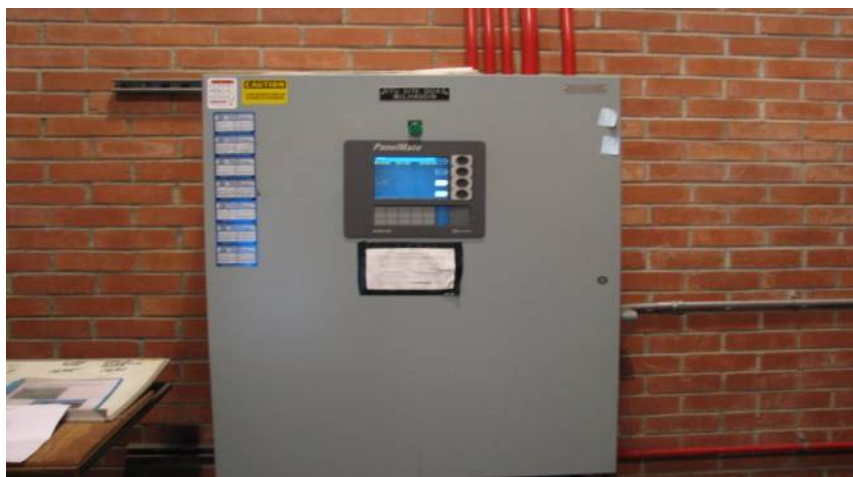
Report Line	10
Location	
Category	Pump Stations
Item	Pump Control Systems

Pump control system.

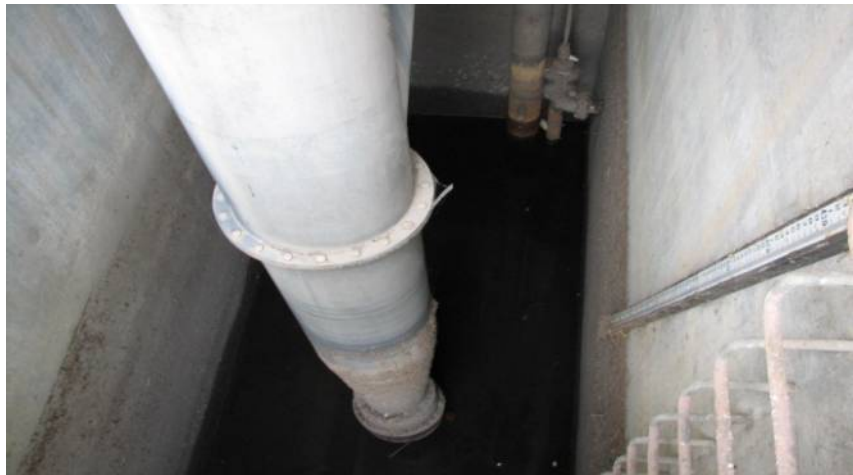
Report Line	11
Location	
Category	Pump Stations
Item	Sumps/Wet Well

View down to the wet well. Very clean.

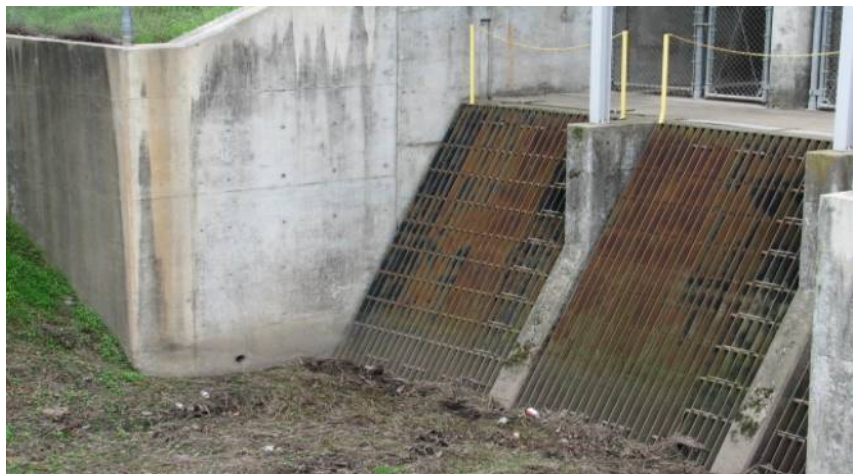
Report Line	12
Location	
Category	Pump Stations
Item	Trash Racks

Some rust is present on the racks but clear of debris.

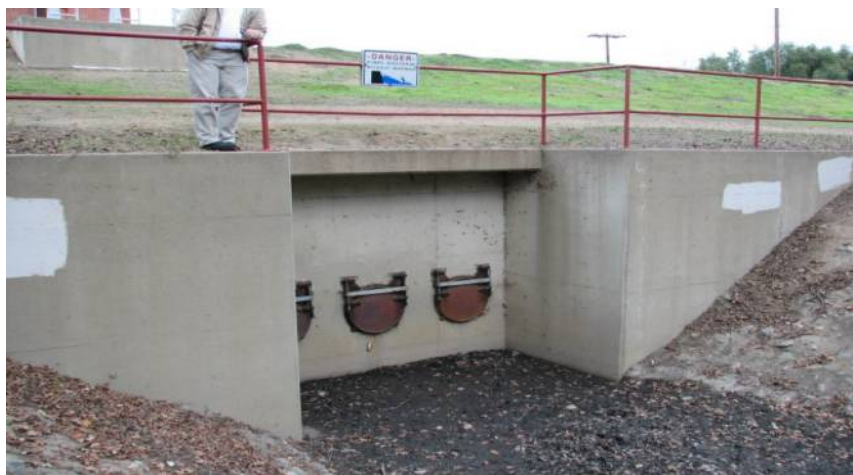
Report Line	14
Location	
Category	Pump Stations
Item	Sluice / Slide Gates

14	Pump Stations	Sluice / Slide Gates		N	Item inspected visually only. Item was not operated during the inspection.		° Y	14
15	Pump Stations	Electric Gate Operators		N			°	15
16	Pump Stations	Manual Gate Operators		A			°	16
17	Pump Stations	Other Metallic Items		N			°	17

View of flap gates. No visible rust or damage.

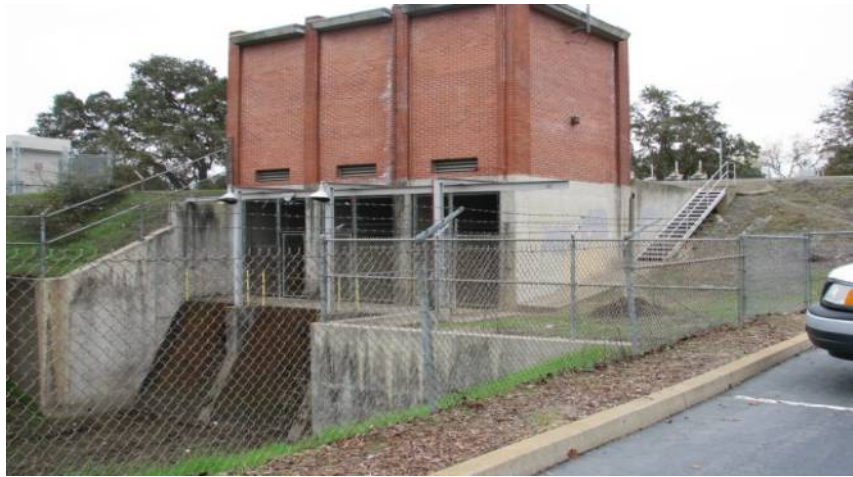
Report Line	20
Location	
Category	Pump Stations
Item	Security Fencing

Rpt Line	Category	Item	Location *	Rating **	Comment	GPS	Photo	Issue
18	Pump Stations	Flap Gates		A	Item inspected visually only. Item was not operated during the inspection.			18
19	Pump Stations	Closure Structures		N				19
20	Pump Stations	Security Fencing		A	Fencing is complete and barbed wire is present.		Y	20
21	Pump Stations	Intake and Discharge Pipes		N	All pipes are underground and cannot be seen.			21
22	Pump Stations	Pressurized Pipe		N	No pipes are visible.			22

View of security fencing.

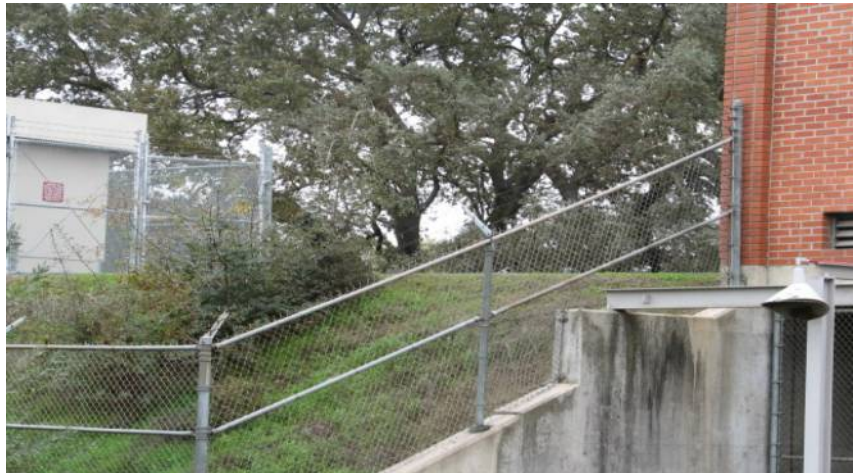
Report Line	20
Location	
Category	Pump Stations
Item	Security Fencing

Another view. Barbed wire is present at the top of the fencing but is not very visible here.
